Product: **SMI Shutter Actuator JA/S**

Type: **JA/S 4.SMI.1M**

Current application program: **Shutter SMI, 4f M/1.2**

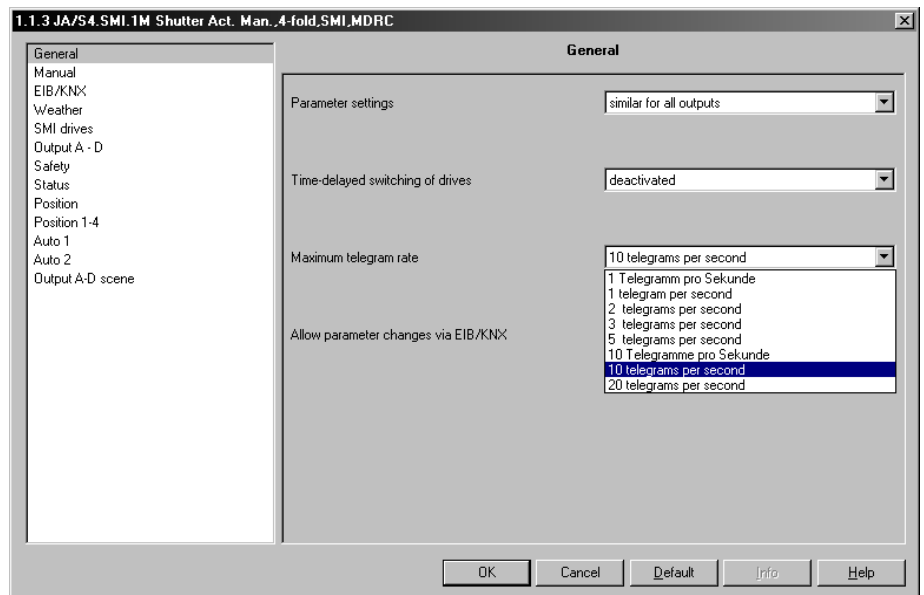
Parameter "Maximum telegram rate" There were two similar Parameter options:
10 telegrams per second

This failure was adjusted.

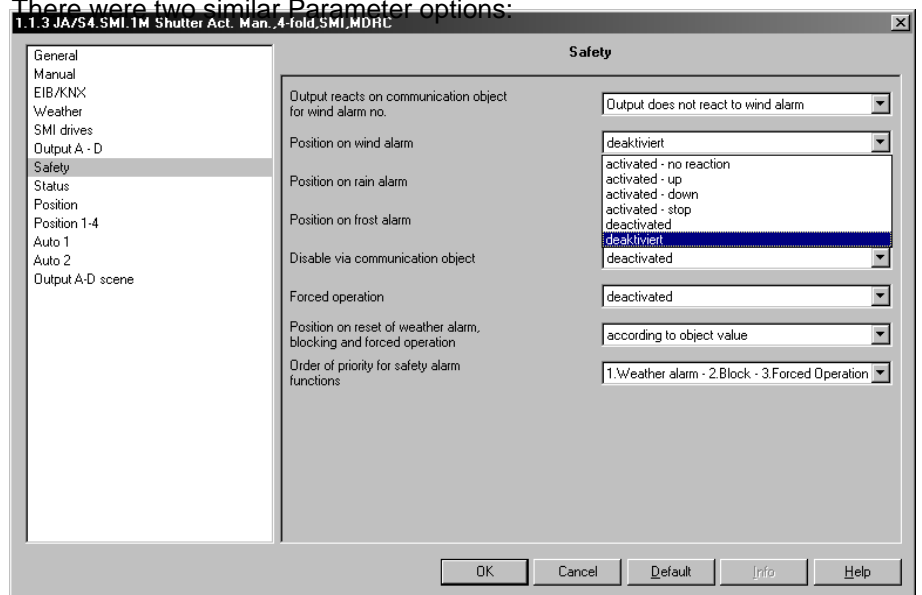
Parameter

“Position on wind alarm”

“Position on rain alarm”

“Position on frost alarm”

There were two similar Parameter options (one in German): *deaktiviert*
There were two similar Parameter options:

This failure was adjusted.
